APPENDIX B - FIELD NOTES

Field Report

Walkthrough of Danbury Branch Line Housatonic Railroad Line

September 8, 2008 to September 11, 2008

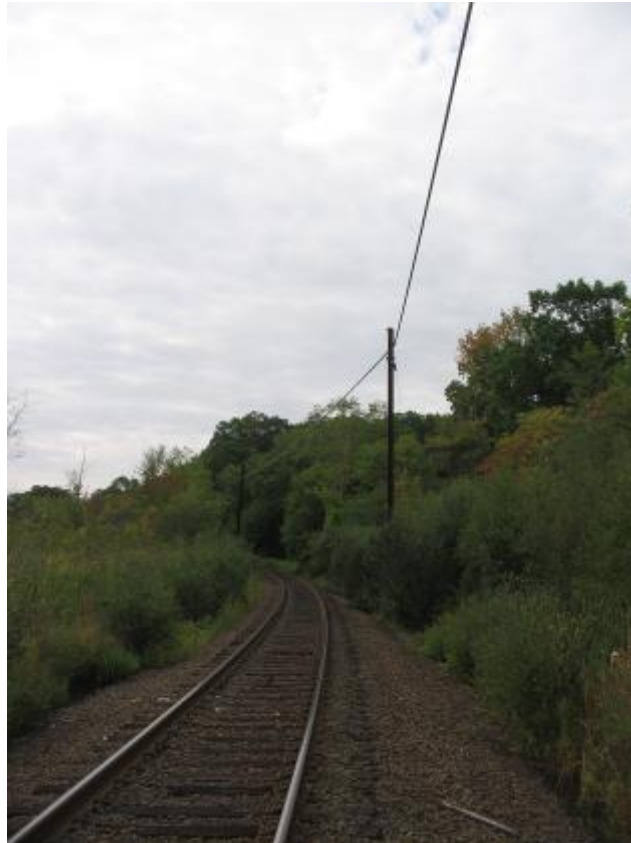
Figure 1 - Typical existing cat. poles supporting fiber optic cable (MNR MP 15.7)

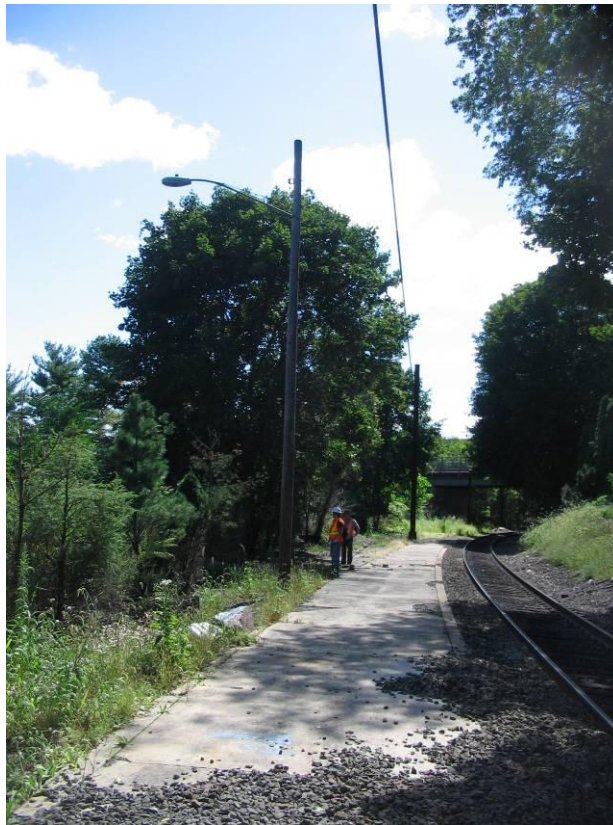
Other Noteworthy Observations: Existing platform located on the east side of the tracks was found at MP 11.90. This is the proposed location for the new Georgetown Station.

Figure 20 - Existing platform. Proposed location for Georgetown Station. (MNR MP 11.9)

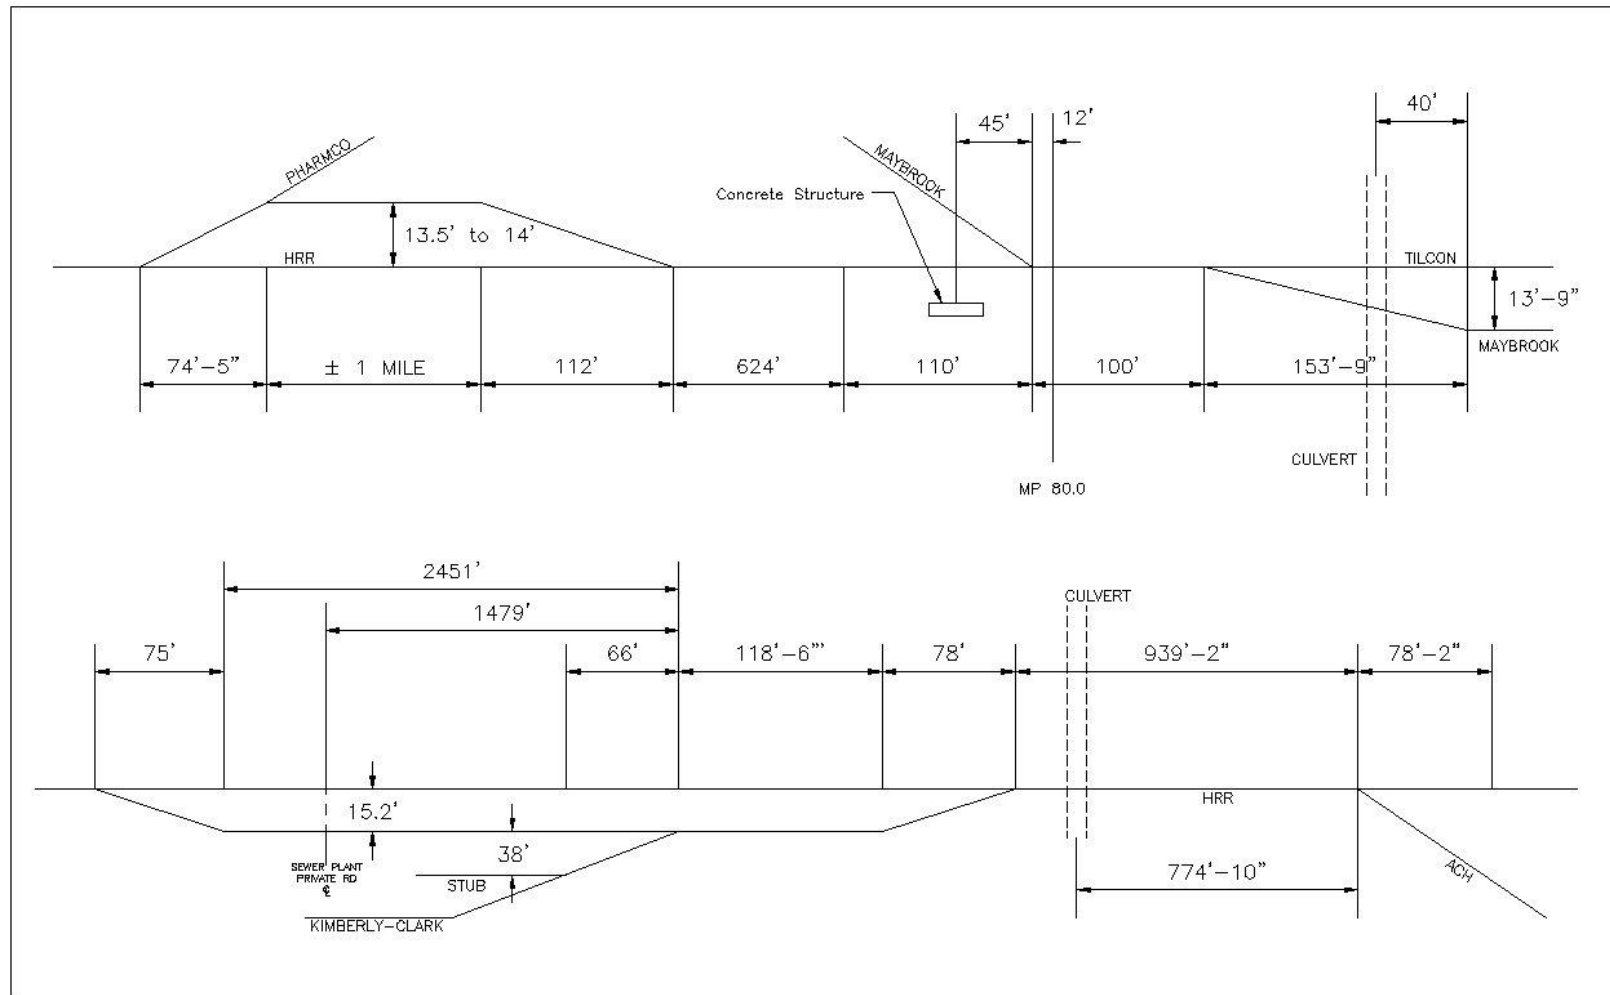
Measurements of sidings were taken at two locations on the HRR line: the siding by PHARMCO and the siding by AC and Kimberly-Clark. The drawing below details the sidings.
